Screenfield Retrofit Saves Greenwood Lakes WRF Time and Money

Customer: Greenwood Lakes Water Reclamation Facility
Industry: Municipal

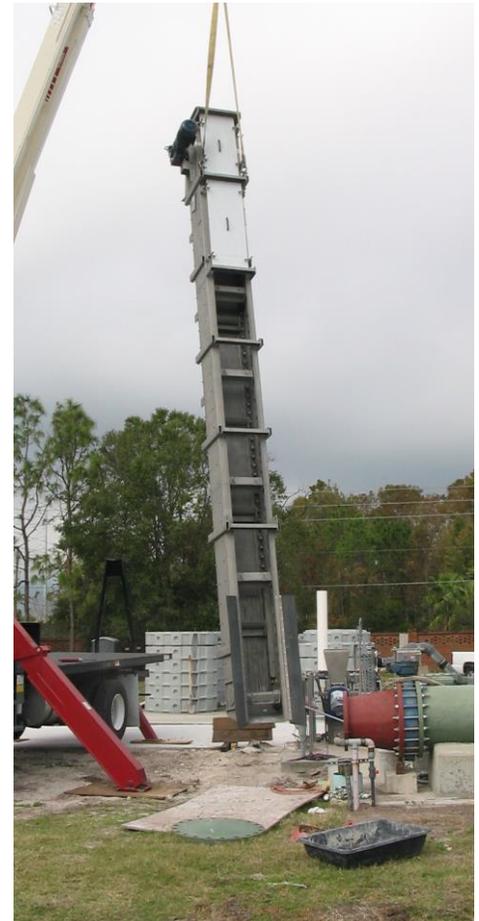
Due to space constraints both screens were removed from the channel individually to execute the retrofit

To perform the retrofit on site, the rakes would be replaced and field modifications were required with respect to the frame. The areas where the screenfield bars attach to the screen must be cut out and replaced with new sections. “Wharton-Smith installed the original screens in 2005 and was a natural choice to execute the retrofit,” said Lee Ann.

Due to space constraints, both screens were removed from the channel individually to execute the retrofit. “Headworks provided the retrofit kit for each screen and we

made the modifications with ease while maintaining the strength of the original product,” Sean Stanford, Project Manager at Wharton-Smith explained.
