Screenfield Retrofit Saves Greenwood Lakes WRF Time and Money

Greenwood Lakes WRF - Seminole County, FL

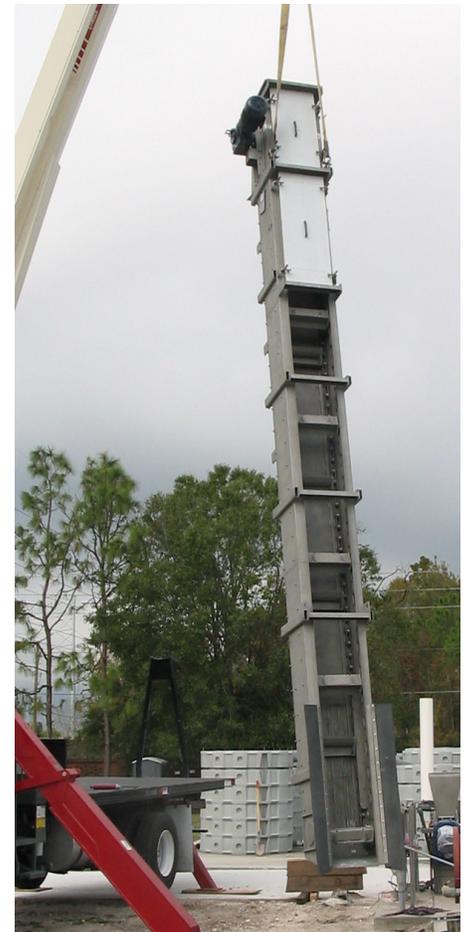
Due to space constraints both screens were removed from the channel individually to execute the retrofit.

To perform the retrofit on site, the rakes would be replaced and field modifications were required with respect to the frame. The areas where the screenfield bars attach to the screen must be cut out and replaced with new sections. “Wharton-Smith installed the original screens in 2005 and was a natural choice to execute the retrofit,” said Lee Ann.

Due to space constraints, both screens were removed from the channel individually to execute the retrofit. “Headworks provided the retrofit kit for each screen and we made

the modifications with ease while maintaining the strength of the original product,” Sean Stanford, Project Manager at Wharton-Smith explained.
